Kiwitechnics Upgrade Installation Problems.

If you have installed a Kiwi upgrade and it is not running here are a list of things you can look at and try.

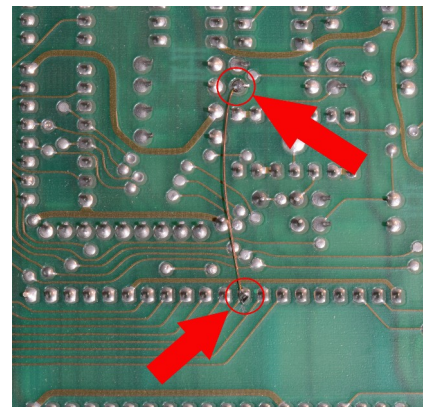
If you find a track that is broken it will need to be repaired. A good way to do this is to use enamelled wire like is used to wind transformers or chokes.
